2 TUBMILL DAM

(ID NO. PA. 488)

4 PHASE I INSPECTION REPORT  
NATIONAL DAM INSPECTION PROGRAM

6 National Dam Inspection Program. Tubmill  
Dam (ID Number PA 488), Ohio River Basin,  
Tubmill Creek, Westmoreland County,  
Pennsylvania. Phase I Inspection Report.

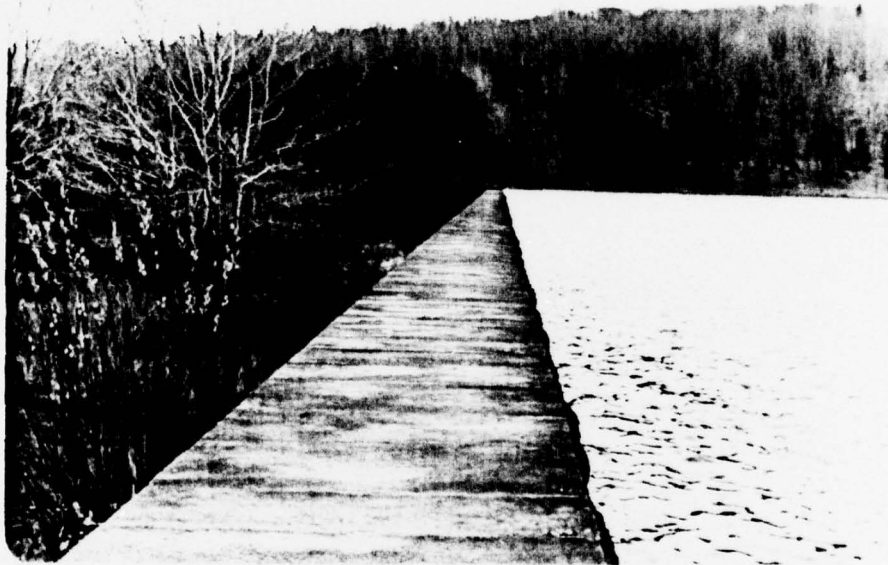
Upstream Face

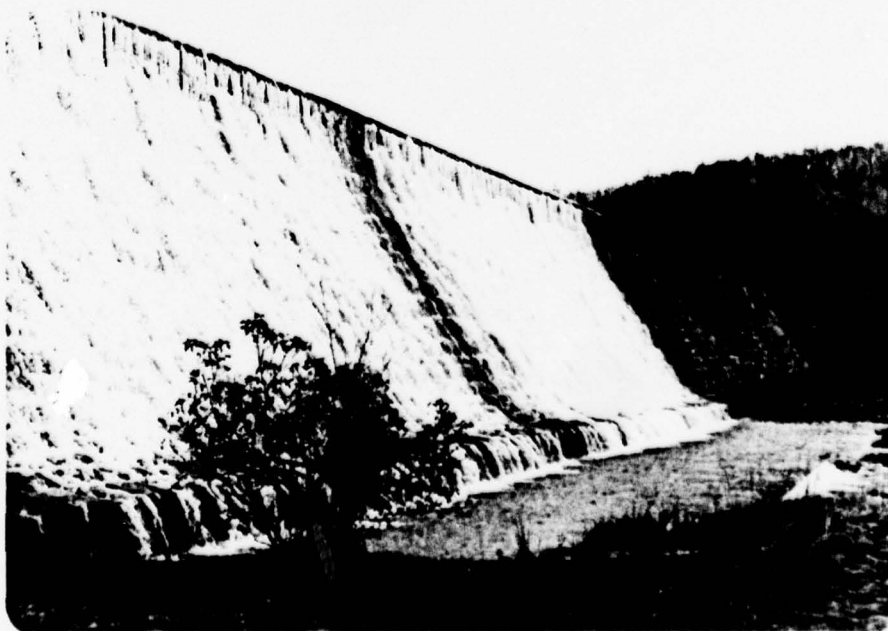
Downstream Face

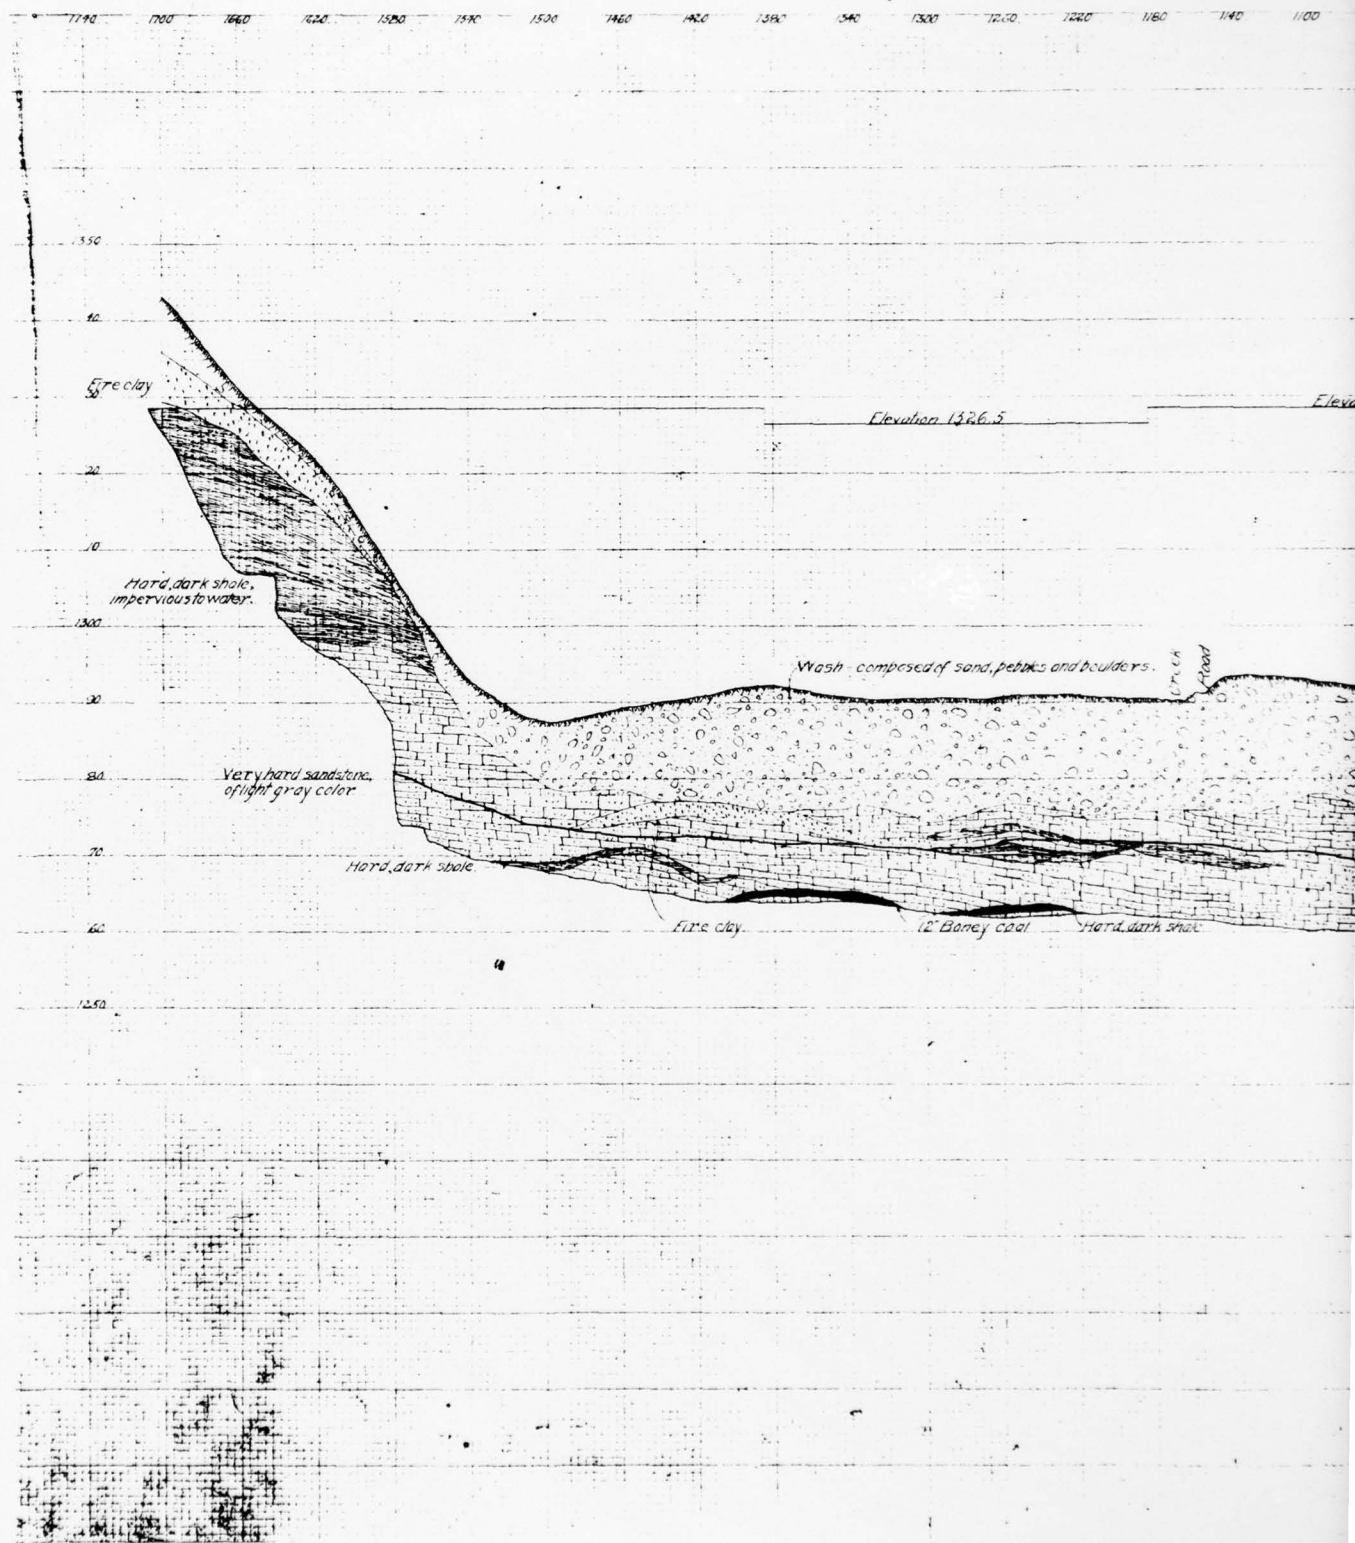
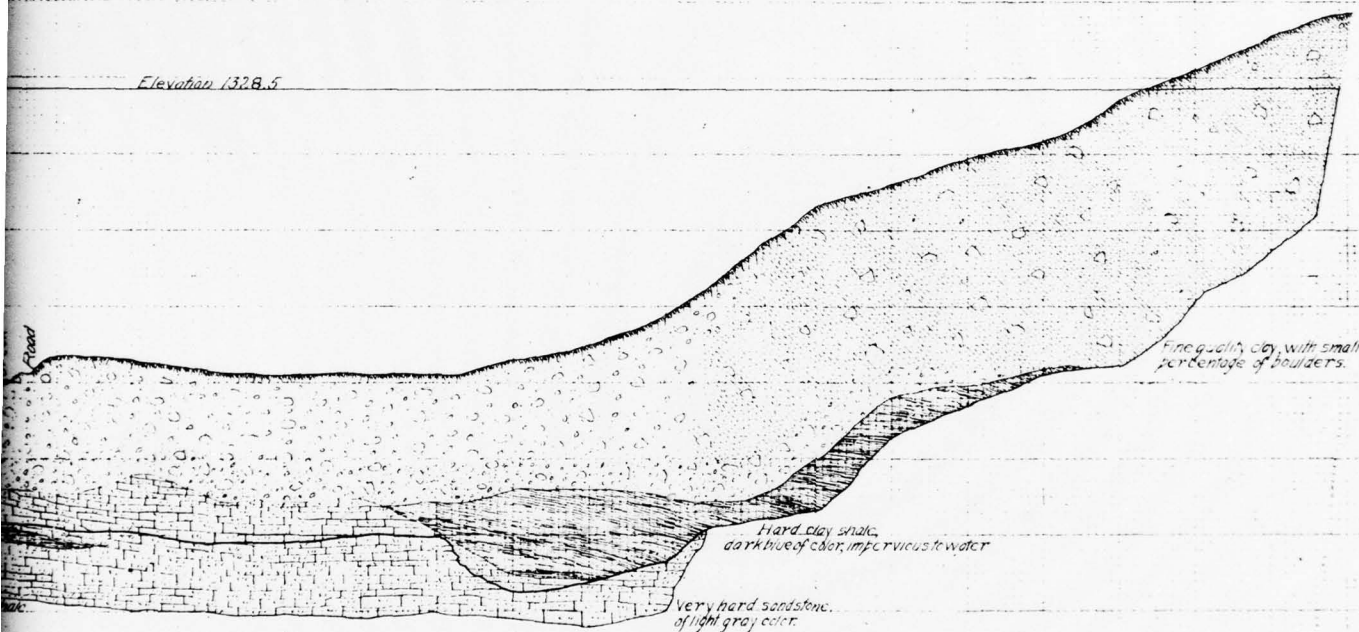
PLATE 4

Plate 4 illustrates the rock formations at the site. The right abutment is shown to consist of fire clay underlain by hard shale to Elevation 1275 and then sandstone. At the valley bottom, the subsurface profile shows 15 feet of sand and boulders underlain by sandstone with isolated seams of coal and fire clay. The left abutment is essentially sand and boulders underlain by shale from Elevation 1290 to valley bottom.

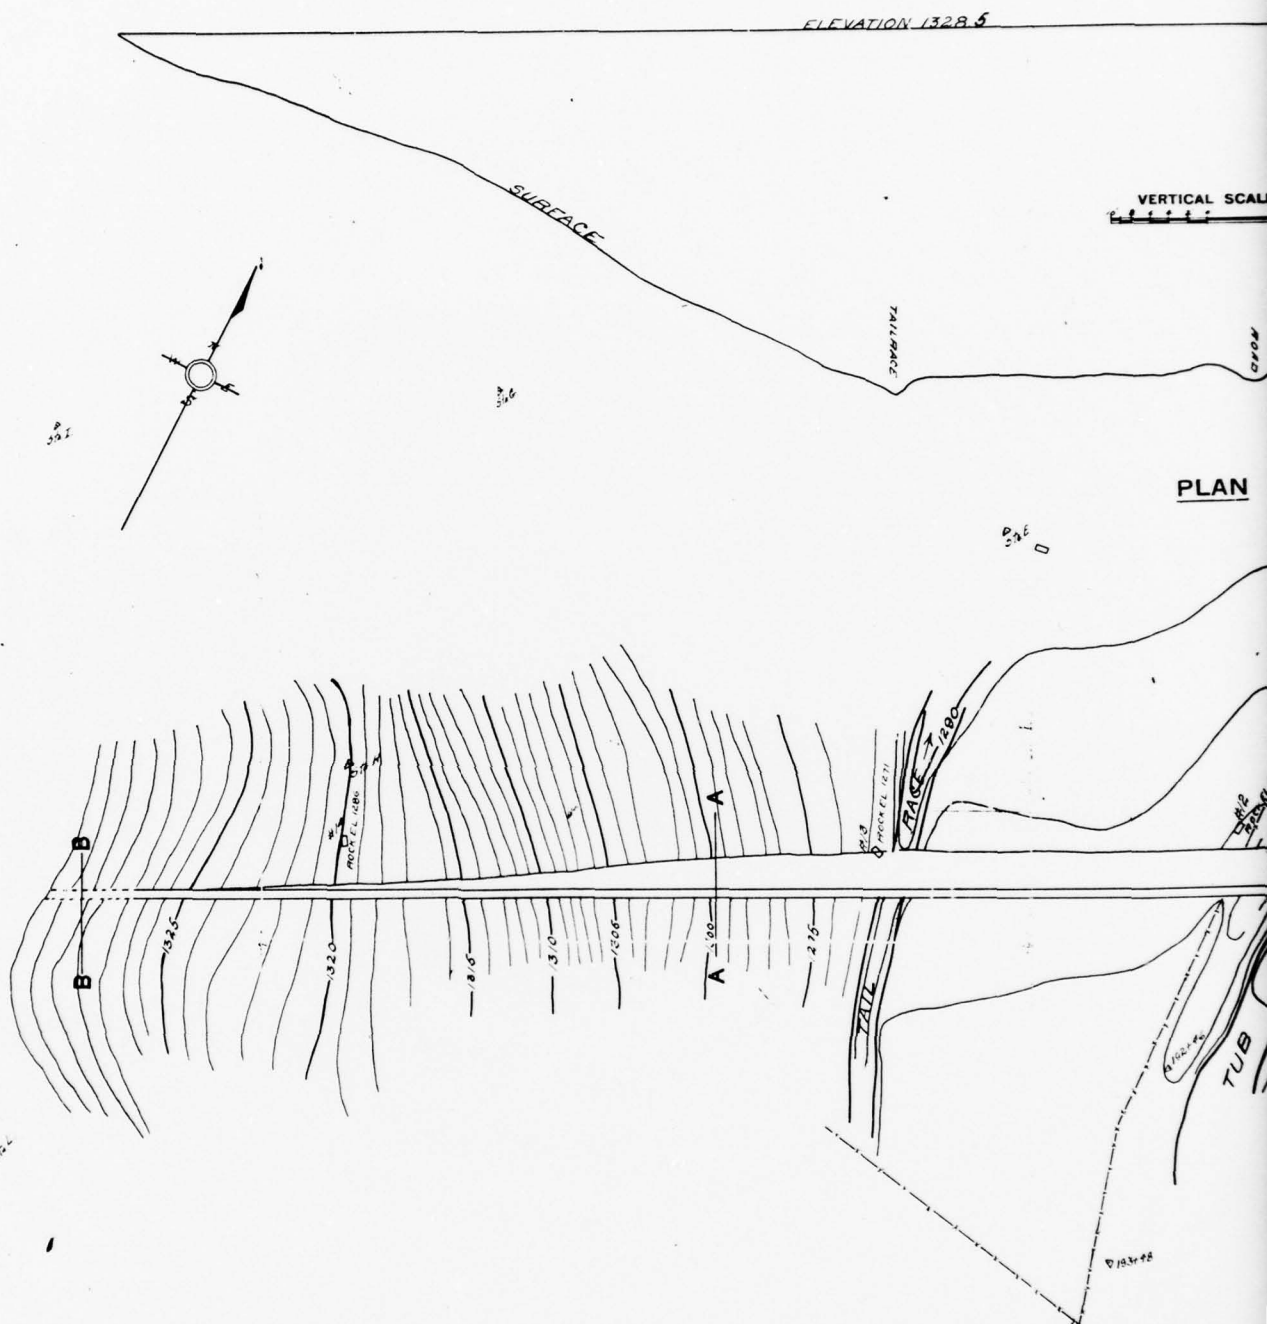
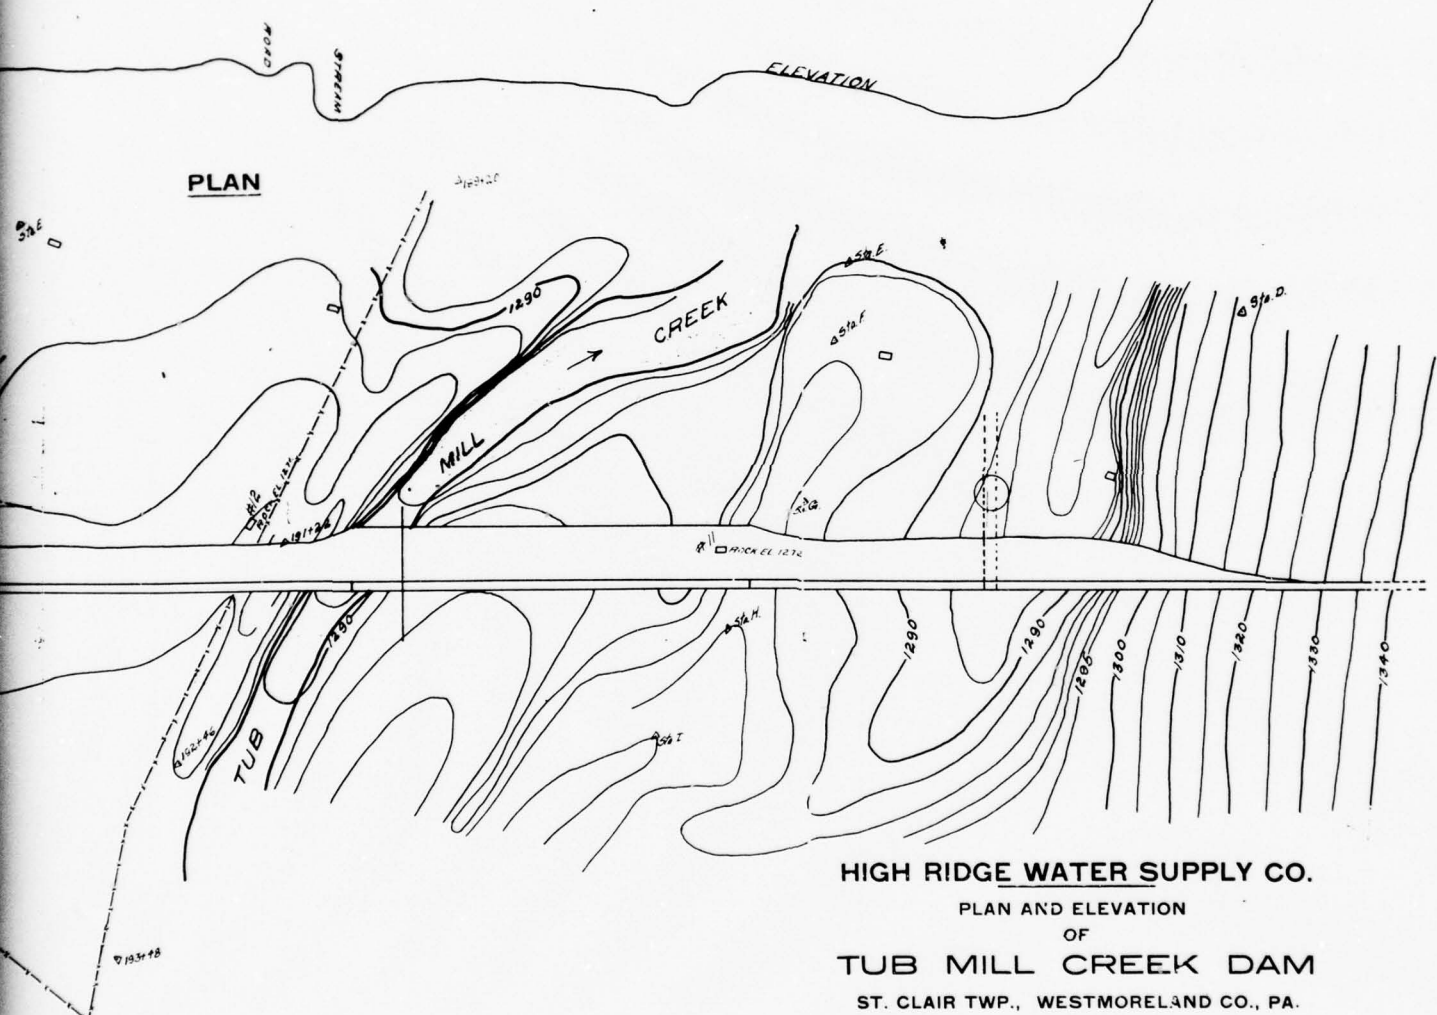
PLATE 5

Plate 5 presents a plan and elevation of the dam.

VISUAL EXAMINATION OF	OBSERVATIONS	REMARKS OR RECOMMENDATIONS
ANY NOTICEABLE SEEPAGE	DOWNSTREAM FACE OF THE DAM WET (NO MEASURABLE SEEPAGE)	(SEE PLATE-5)
STRUCTURE TO ABUTMENT/EMBANKMENT JUNCTIONS	NO VISUAL SIGNS OF DISTRESS NO SEEPAGE	
DRAINS	NONE FOUND	
WATER PASSAGES	NONE	
FOUNDATION	NO PERCEIVABLE SIGN OF DISTRESS.

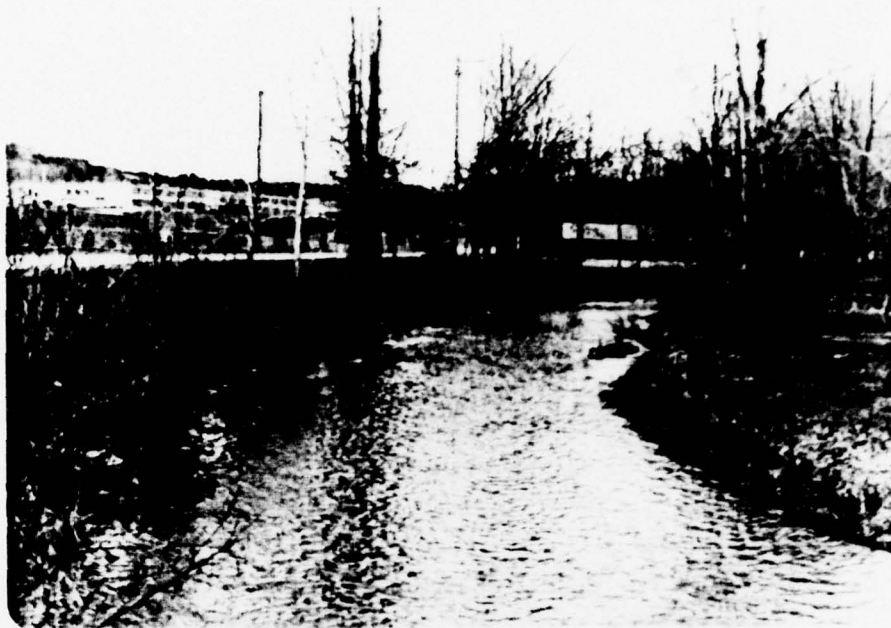
Photograph No. 11

e. Downstream Channel. Tubmill Creek, for most of its course, flows through a meandering streambed. Sketches of the bridges over the stream in the first three-mile reach from the dam are included in Appendix A. Photograph 11 shows the stream along Route 711. The bridge on Route 711 over Tubmill Creek is shown in Photograph 12. The downstream channel was described in Section 1.2.

Flood plain along Route 711. (Note high school in left upper corner.)

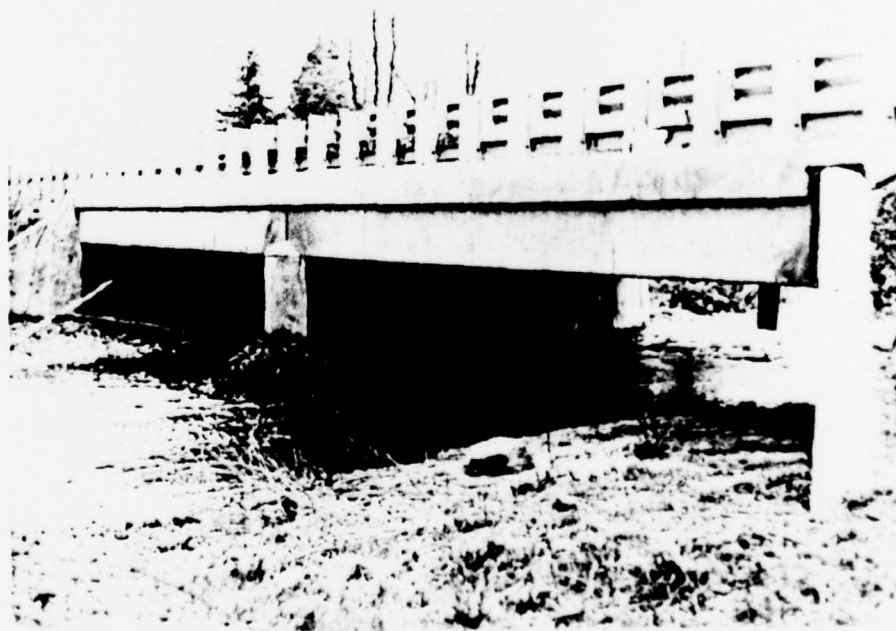
Photograph No. 12

Bridge on Route 711.
